LATOSKY INSPECTION COMPANY
INSPECTION REPORT

Street Address

PART ONE

BACKGROUND DATA

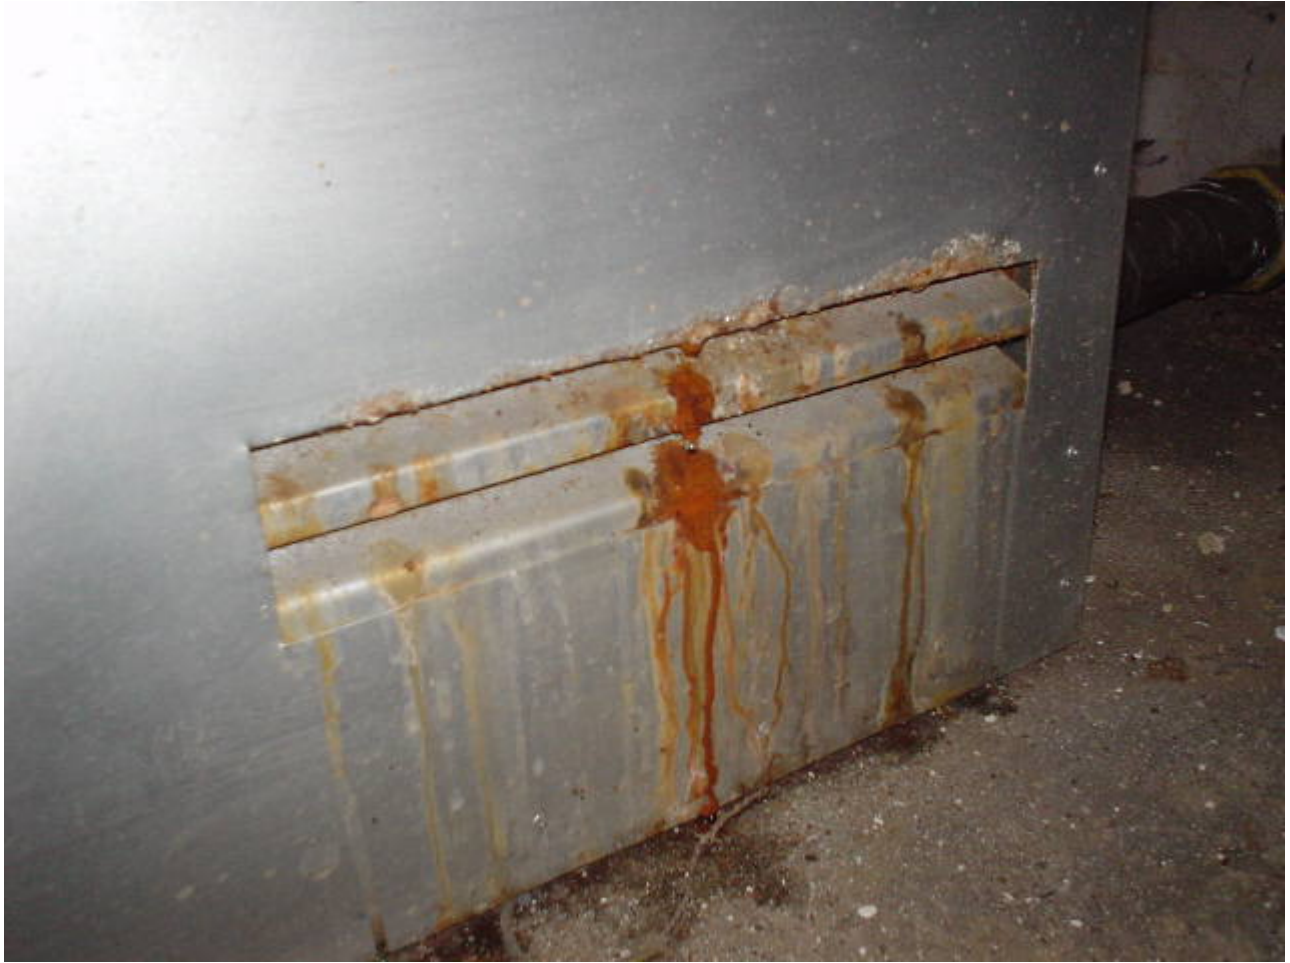
Water was found to be leaking through the sheet metal enclosure along the right side of the boiler. Because the sheet metal enclosure could not be removed during the inspection it could not be determined why or what part of the boiler was leaking. Have a heating contractor in for a further evaluation and to make the necessary repairs.

Leak along right side of boiler.

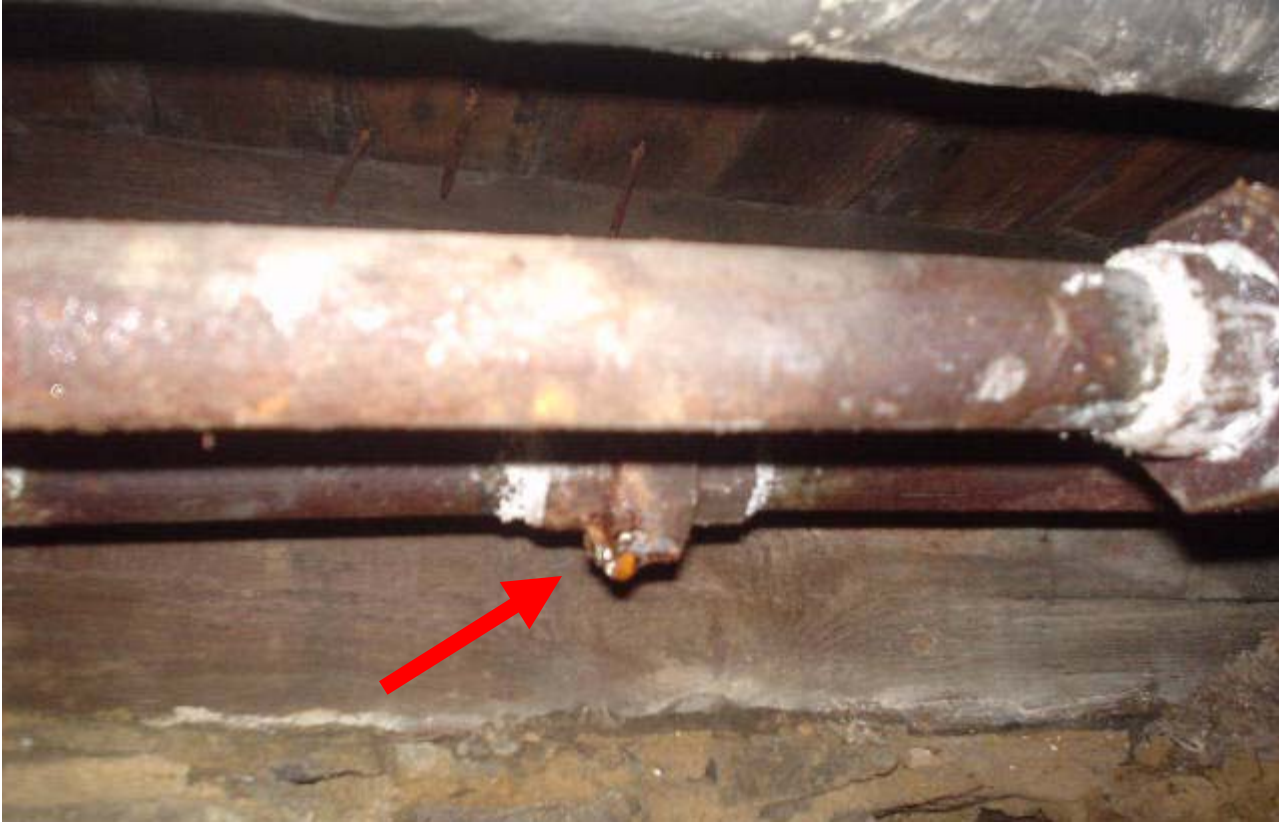
A fitting in the hot water heat piping along the left foundation wall in the back basement room leaks. Water was found to be leaking from this fitting at the time of the inspection. Have the heating contractor make the necessary repairs.

Leak in hot water pipefitting.

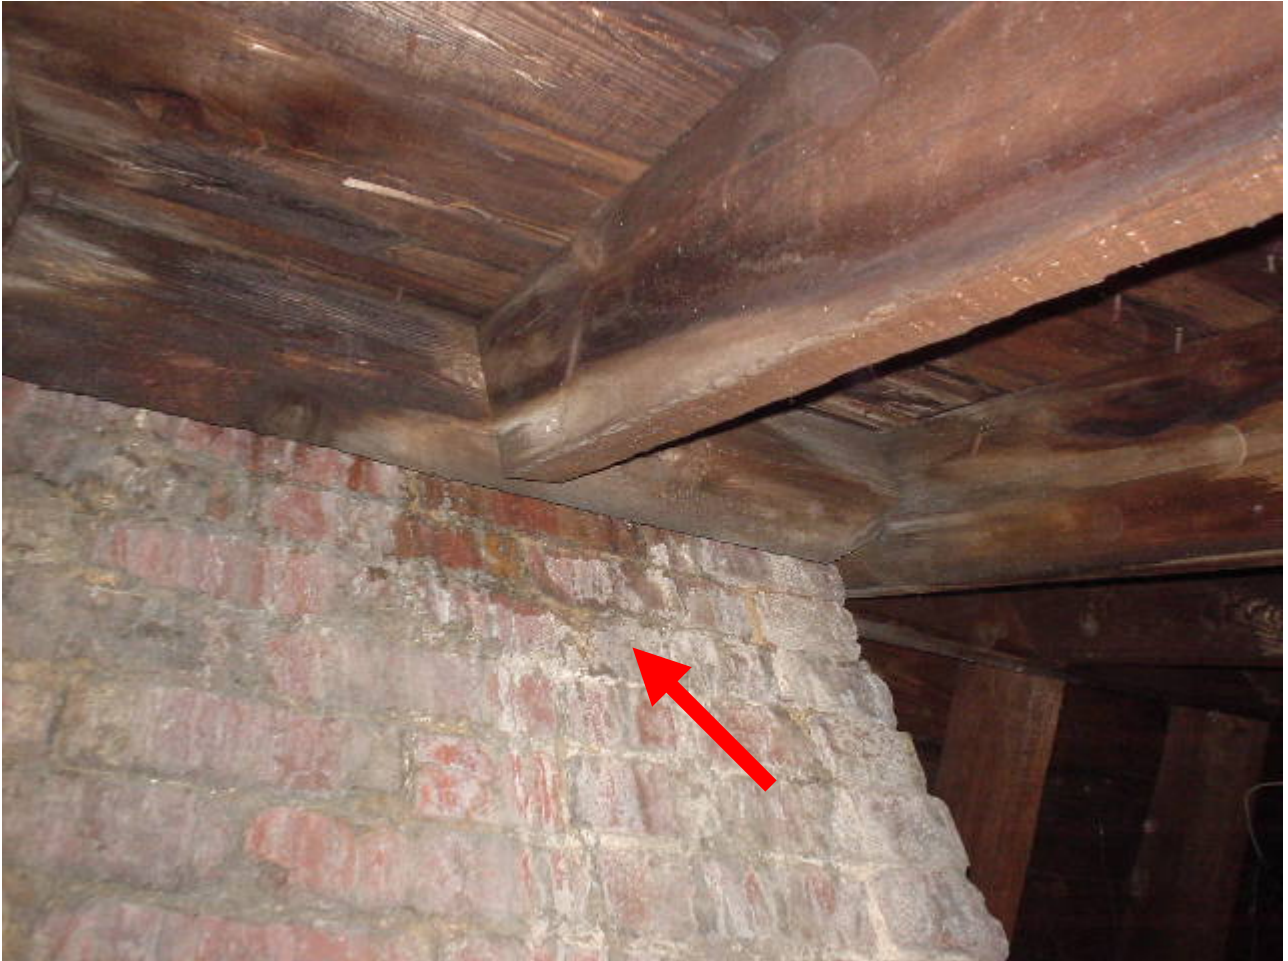
The roof leaks around the chimney structure in the center of the house. Water was found to be leaking into the attic space and second floor hallway ceiling at the time of the inspection. Have a roofing contractor in to make the necessary repairs.

Leak around chimney structure in attic space.

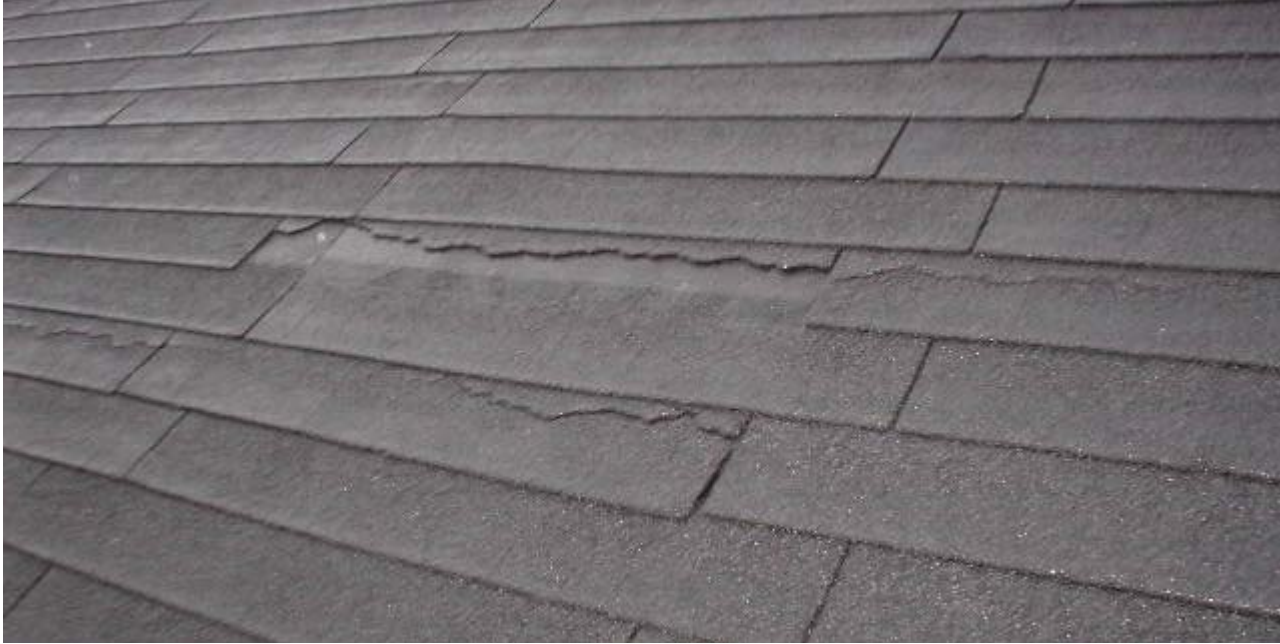
There are few roof shingle tabs missing from the right face of the main house roof. Though these missing shingles do not appear to be allowing the roof to leak the shingles should be replaced to prevent a potential roof leak. Have the roofing contractor replace these shingles.

Missing shingle tabs.

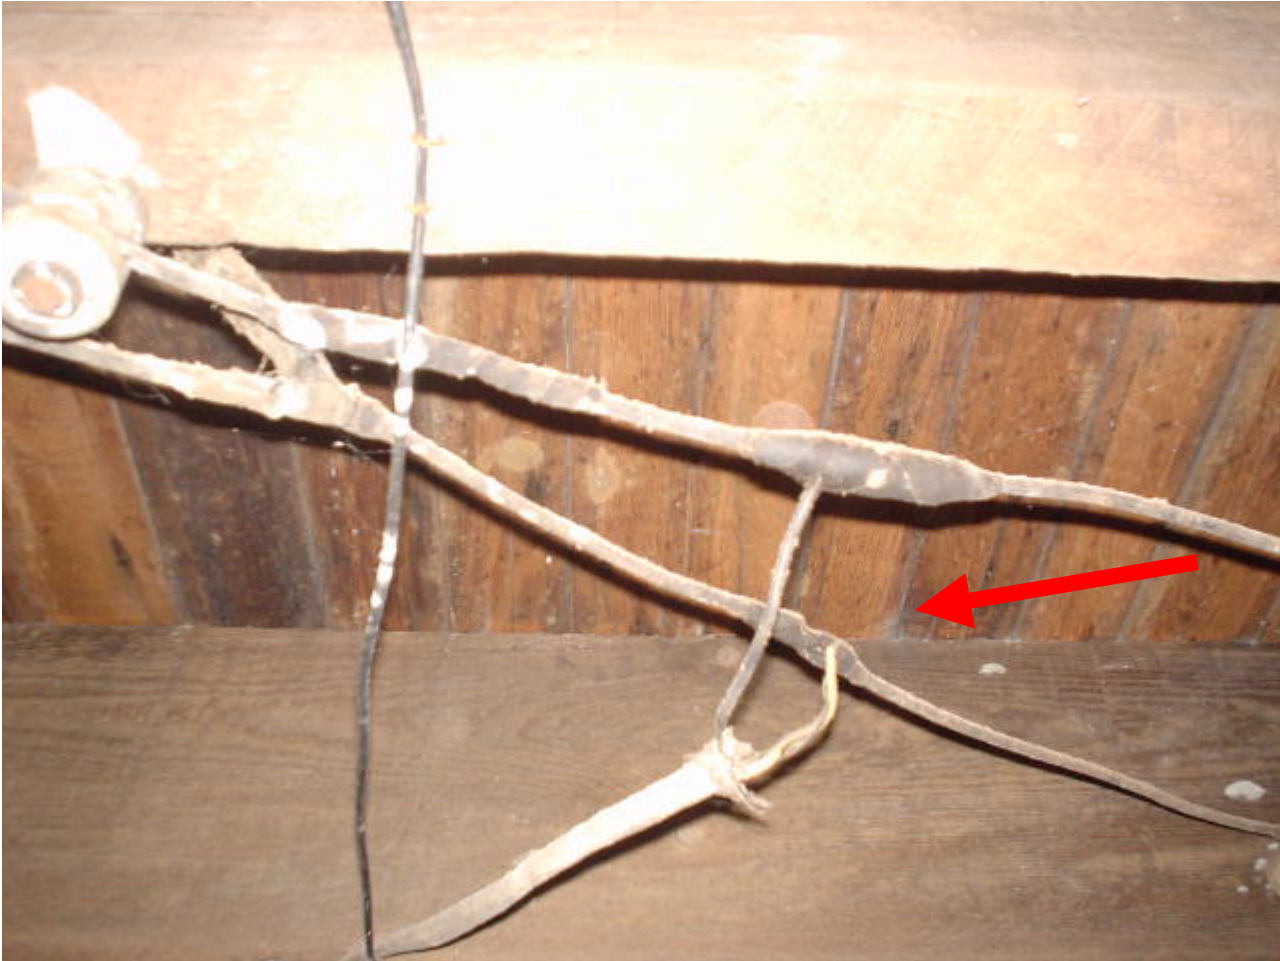
The building wiring includes visible, active knob and tube type wiring in the basement ceiling and attic space (and certainly elsewhere in the building, obscured within walls and ceilings). There is at least one location in the front right crawlspace ceiling where an electrical connection has been made between the original knob and tube wiring and updated wiring. This connection has not been made inside a junction box and was not per code when the work was done. Primarily, however, this splice can cause more current to flow through the original knob and tube wiring than originally intended. The usual corrective action in this situation is to remove the visible active knob and tube wiring in the process of fixing the connection. This usual approach allows the knob and tube wiring within the walls and ceilings to remain (because, when properly connected to the house wiring system, the obscured knob and tube wiring is less problematic).

Wire splice between updated electrical wiring and knob and tube wiring.

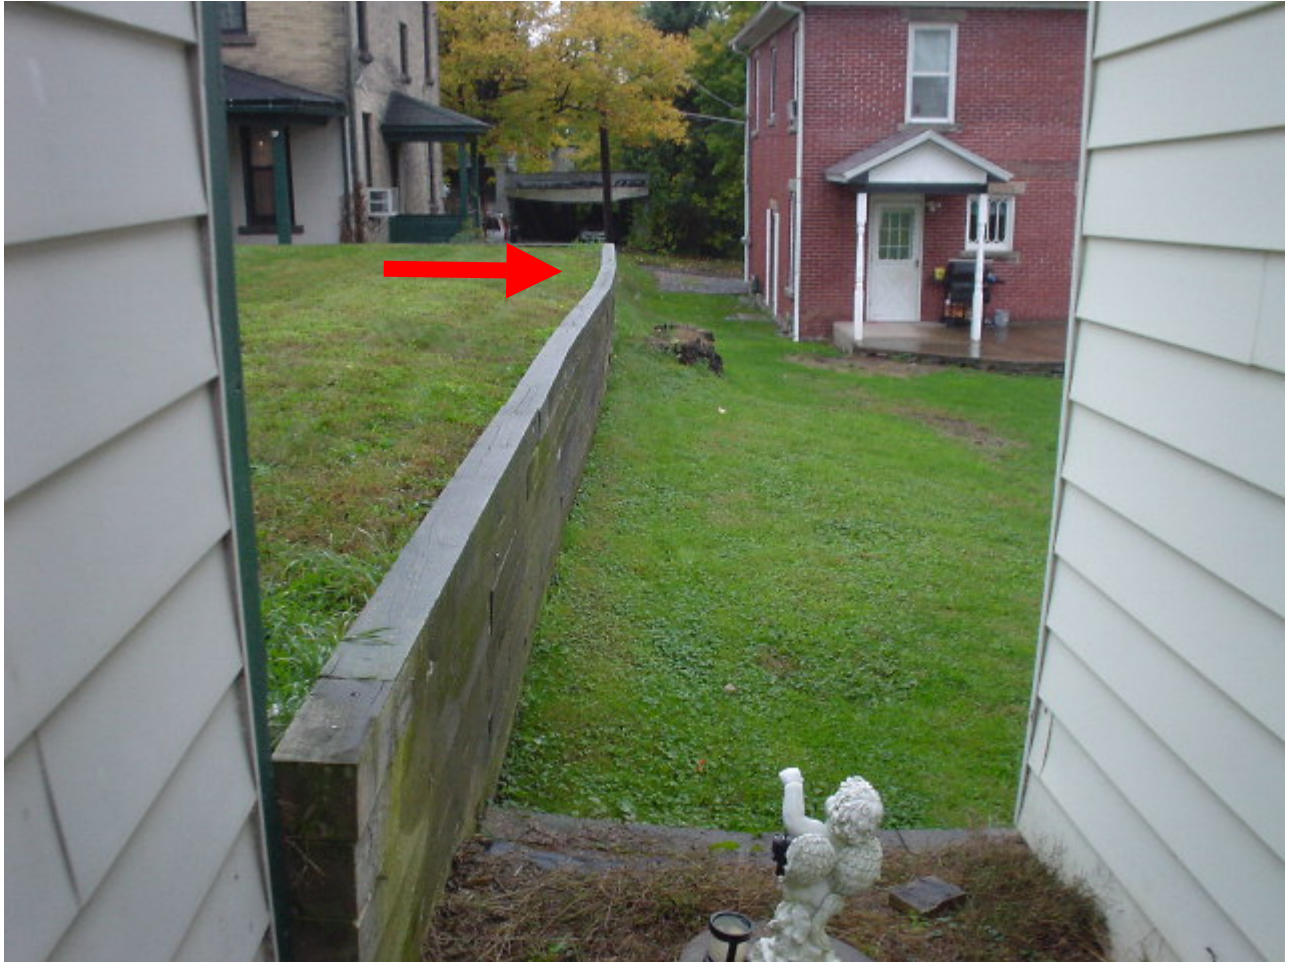
The wood retaining wall along the left side of the back yard and behind the house has tilted and bulged significantly. Forces from the ground behind the wall are pushing the wall. The wall is not ready to fall over but continued shifting can be expected because the forces haven't been reduced and the wall is becoming less capable of withstanding these forces - as the wall departs from its original flat and vertical or back tilting configuration). Continued shifting will eventually cause the wall to fall over. The wall will eventually need to be rebuilt. Note that this also applies to the retaining wall along the right side of the pool.

Bulging retaining wall along left side of back yard.

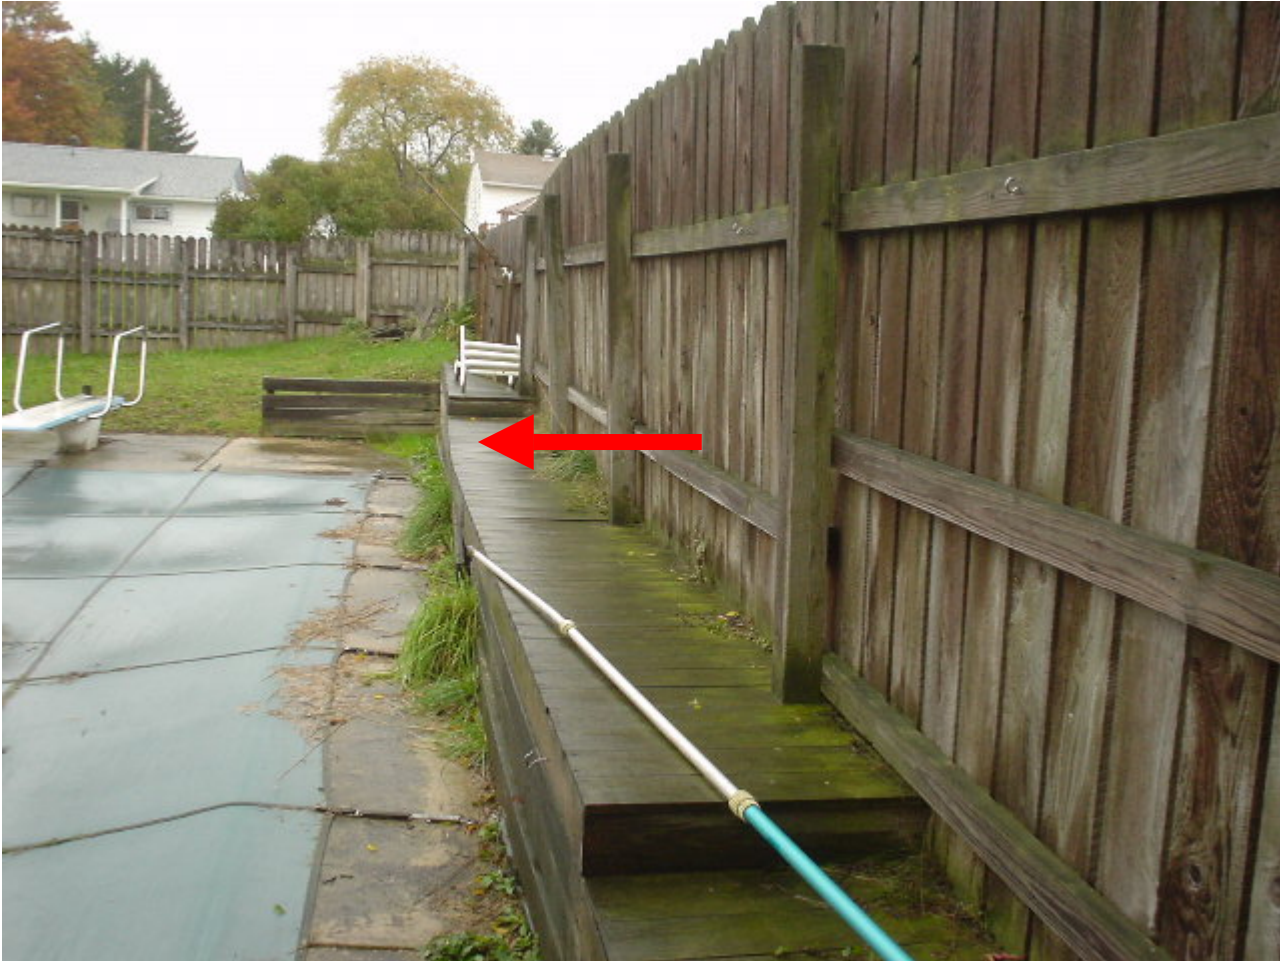
Bulging retaining wall along right side of pool.

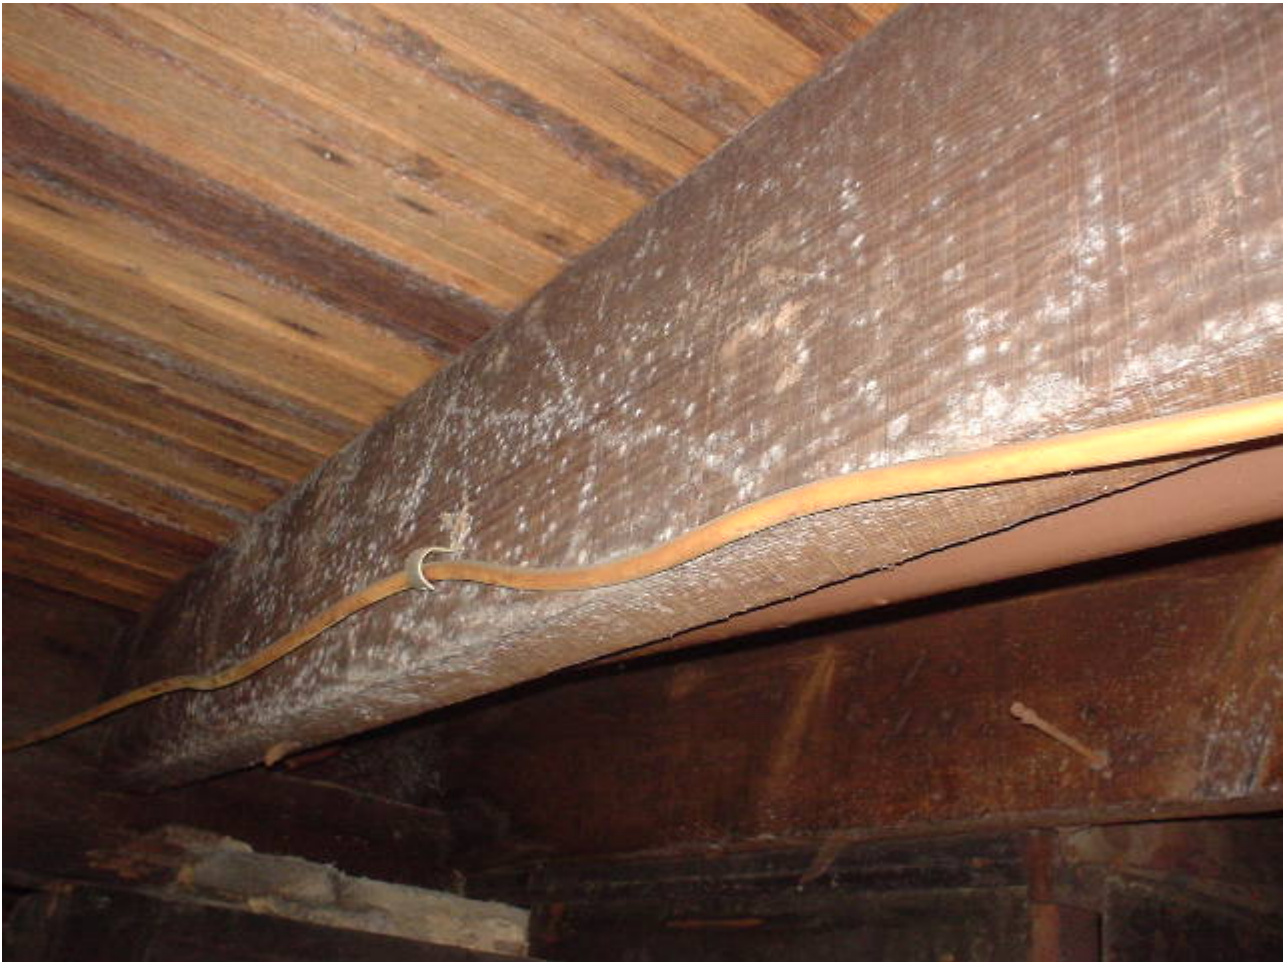
Suspected mold on basement ceiling joist.

Generally, the EPA web site suggests that the mold be removed and that the dampness that causes the mold be eliminated.

In addition, it is suggested that a dehumidifier be operated. Running a dehumidifier will reduce the volume of water that condenses on the cooler inside surfaces of the foundation wall.
